Testing of bearing materials for large two-stroke marine diesel engines

Vølund, Anders; Klit, Peder; Persson, Sebastian

Proceedings of the Institution of Mechanical Engineers, Part J: Journal of Engineering Tribology

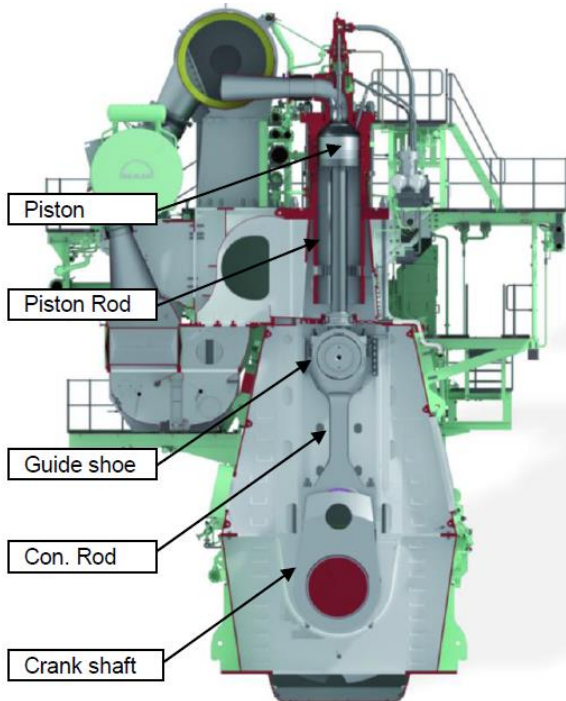
Figure 1: Cross Sectional View of Large Two-stroke Marine Diesel Engine (Important Components Highlighted)

Bearings for large two-stroke marine diesel engines are typically in service for the entire lifetime of the engine – up to 20-30 years is not unusual service life (Figure 1). The bearing shell is installed in the engine and firmly positioned by the design of the structure surrounding the bearing. The design of these bearings is to a large extent based on empirical knowledge in combination with simulations. These simulation results are compared to basic design rules and thus assisting in the validation of new designs. The typical white metal bearing shell, consist of a base material (steel) on which the white metal has been applied. Traditionally bearings installed in MAN Diesel & Turbo SE (MDT) engines were equipped with white metal as bearing lining. This mindset changed years back when certain bearings in certain engines started to show less good performance due to fatigue cracks at bearing edges. This required a modification in order to address this issue. The solution was the introduction of

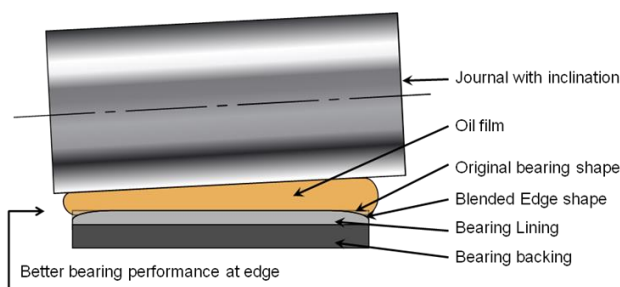
Figure 2: Bearing Design / Blended Edge

The „Blended Edge” (Figure 2) design compared to the conventional design increased the minimum oil film thickness significantly thus enabling the possibility to re-introduce the white metal bearing, with its superior tribological properties. Having this in mind there is still a need for understanding the mechanisms in relation to fatigue of white metal bearings.

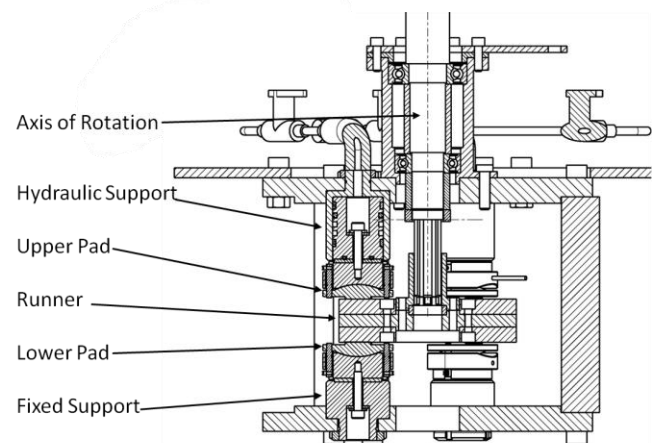
Figure 3: Cross section through assembly drawing showing the test specimens positioned in loading arrangement with Lower and Upper Pad pressed against the test specimens by hydraulic actuation. The test specimens (The Discs mounted on each side of the Runner) are connected to the drive shaft via a parallel spline connection allowing the runner with test discs to adjust in vertical position and to adapt for a small misalignment in the small gap between the disc and the splined hub.

The Disc Fatigue Test Rig (DFTR) (Figure 3) was designed as a collaboration between The Technical University of Denmark (DTU) and MDT with the purpose to test white metal coatings under realistic bearing conditions, in a confined time-frame (Klit, 2013). The disc fatigue test rig has been developed in the EC-project ‘Hercules-C’. The test disc consists of three parts, an upper and lower disc with lined white metal on the outer and a middle disc which is used to assemble the set of discs (Figure 3). The design allows for two tests with almost the same environment to be tested at the same time. The test-rig simulates a scale model of a thrust bearing. The purpose with this test-rig is, through experimental analysis, to clarify some of the reasons and mechanisms for crack formation and growth in white metal coatings due to fatigue. With a better knowledge of bearing fatigue the bearings can be designed with lower friction losses.

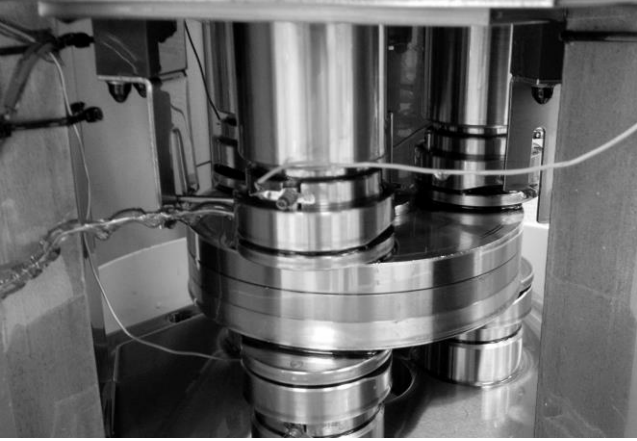
Figure 4: Physical Setup of the DFTR showing the disc and the three pads facing each white metal disc .

Further info can be seen found in (Klit, 2013) and Figure 4

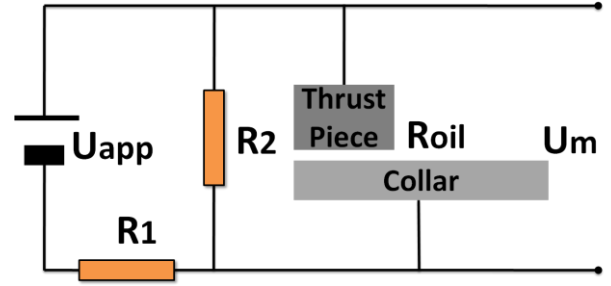
Figure 5: Schematic setup of the ERM – system.

The bulk temperature of the oil was controlled using a PID controller. The coefficient of friction was determined from a torque measurement. The temperature of the thrust piece was measured as well as the Electrical Resistance Measurement (ERM), (Voelund, 2010). The ERM principle is shown in Figure 5 and is basically a resistance measurement of the oil film in the gap between the runner and the pad. Each pad is electrically isolated from the disc thus making it possible to monitor when solid contact between a pad and the disc occurs. The ERM was installed in order to have a simple system for indication of a system change (crack development). Since the oil film thickness between the thrust piece (each pad) and the collar (disc) was only a few microns wear particles can be detected to some extent using this rather simple setup (Eq.1).

$$U_m = \frac{R_2 R_{oil}}{R_1 (R_2 + R_{oil}) + R_2 R_{oil}} U_{app} \quad (\text{Eq.1})$$

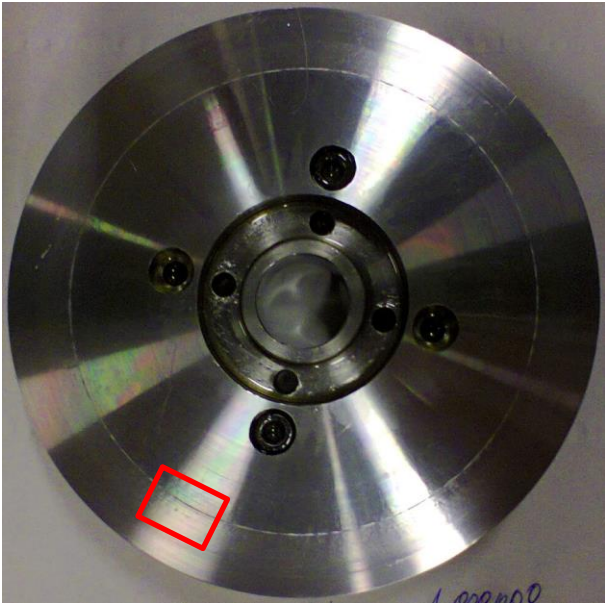
Figure 6: Disc after 1.0×10^6 cycle. The marked area is denoted 'Location A'.

Nothing out of the ordinary was observed in the ERM-signal - see Figure 12. The same can be seen on the running surface, which is shown in Figure 6 and a close-up of one of the locations in Figure 9. After reinstalling the disc the experiment was resumed. Shortly after another 0.6×10^6 cycles an indication was observed on the ERM-signal - shown in Figure 13. Having extracted the disc the following general appearance was observed – see Figure 7. In Figure 7 the same area as chosen in Figure 9 was once again inspected in the microscope revealing the image shown in Figure 10. After re-installing the disc once more the system failed shortly after. The global count was now 2×10^6 cycles. The disc was now severely damaged – see Figure 8 and the area of interest even more – see Figure 11.

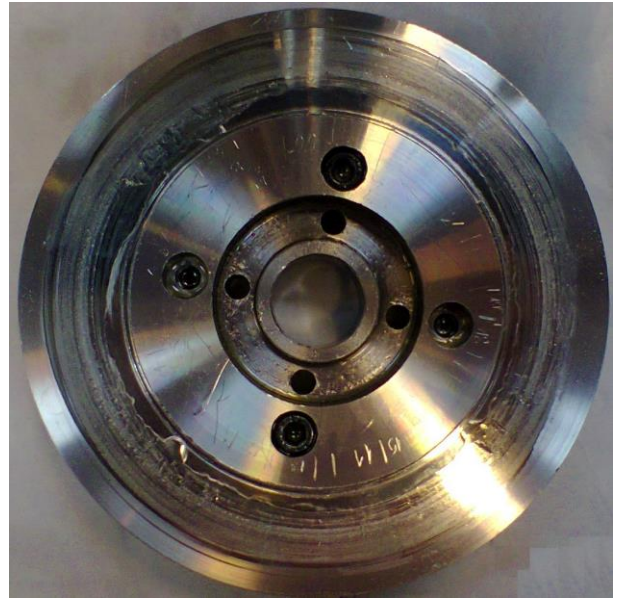
Figure 8: Disc after 2.0×10^6 cycles

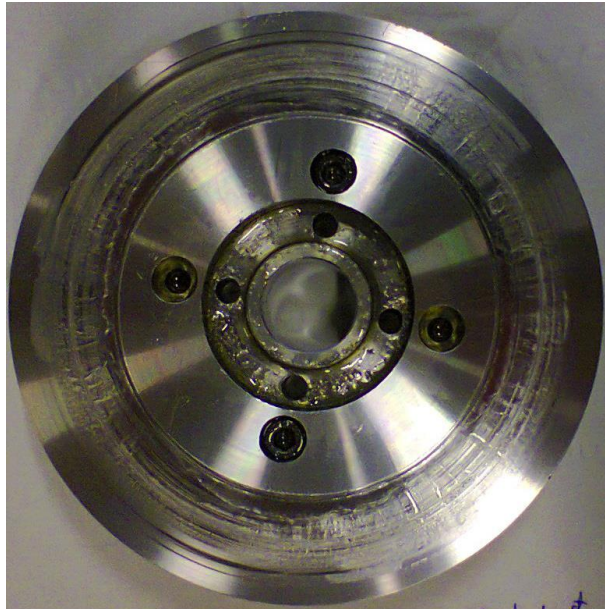
Figure 7: Disc after 1.6×10^6 cycles

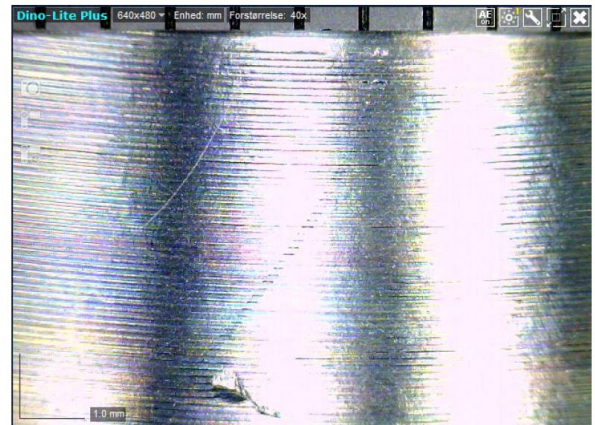
Figure 9: Close-up on disc in location A - possible crack on disc after 1.0×10^6 cycles.

The development of one of the fatigue damages is shown for the 3 discrete times - Figure 9, Figure 10 and Figure 11. This damage spread across the entire disc after 2.0×10^6 cycles leading to a completely damaged disc. From Figure 9 -Figure 11 it can be seen how the damaged area evolves and destroys the running surface. Both cracks and smearing of the white metal can be observed indicating that the load carrying capacity is greatly reduced thus leading to larger pressures and lower separation between the pad and the disc, eventually leading to bearing failure.

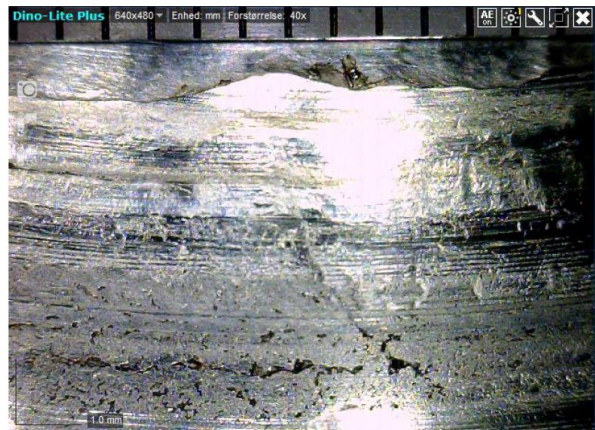
Figure 10: Close-up of location A after 1.6×10^6 cycles now showing damaged surface. Both cracks and smearing of the white metal surface can be observed.

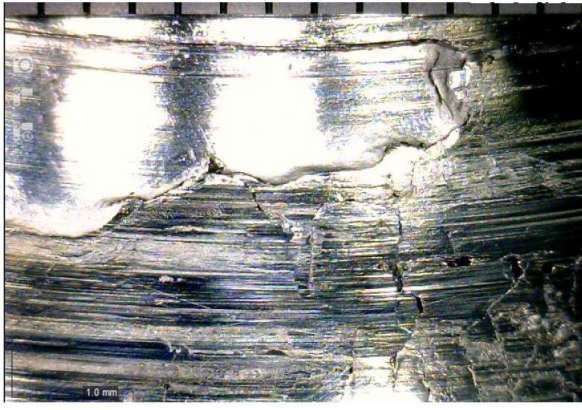
Figure 11: Close-up of location A after 2.0×10^6 cycles now showing severely damaged surface. Both cracks and smearing of the white metal surface can be observed

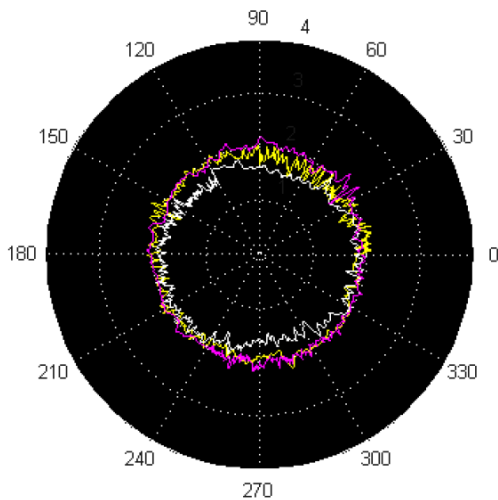
Figure 12: ERM Signal after 1.0×10^6 cycles, revealing no contact between pad and disc. The three lines show the measured voltage drop across the individual pads and the disc. Each color represent one pad. The signal is mapped onto the disc making sure that a crack being formed will show up on all three signals on the same angular position. The radial amplitude of the signal shows the amount of solid contact between a pad and the disc.

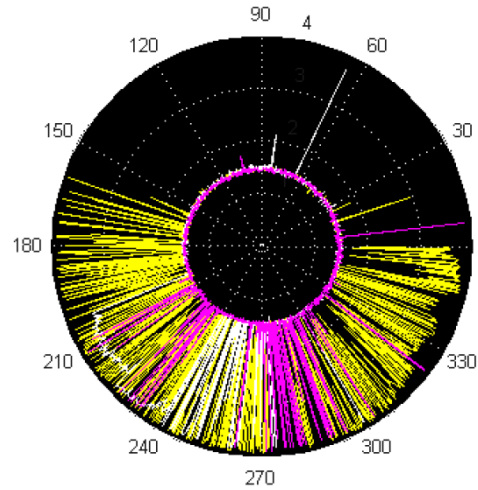
Figure 13 ERM Signal after 1.6×10^6 cycles reveals that contact between the pads and the disc is present
